PROCEEDINGS THE INSTITUTION OF CIVIL ENGINEERS

PART II
FEBRUARY 1953

Airport Paper No. 21

“The Organization of Airport Construction”

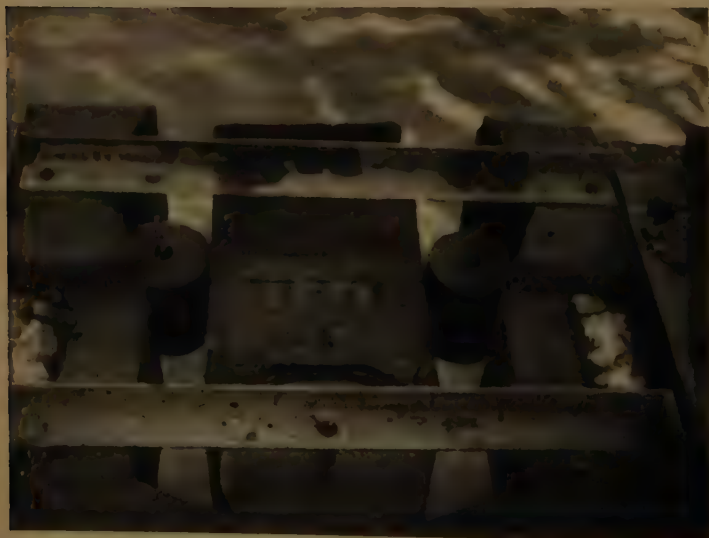
Fig. 37

RUBBER COMPRESSION CYLINDERS AROUND HEAD OF FENDER PILE

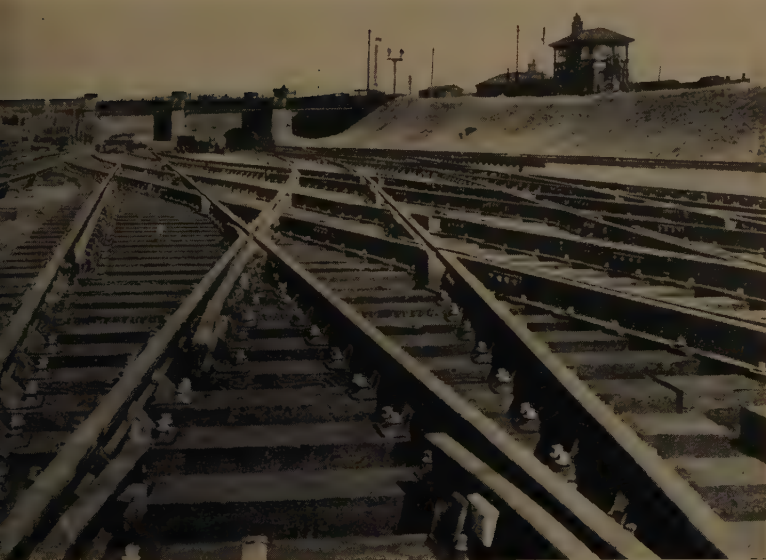
Fig. 1 (b)

REPLACEMENT INCORPORATING CAST-MANGANESE STEEL. VIEW TAKEN IN LAY-OUT YARD

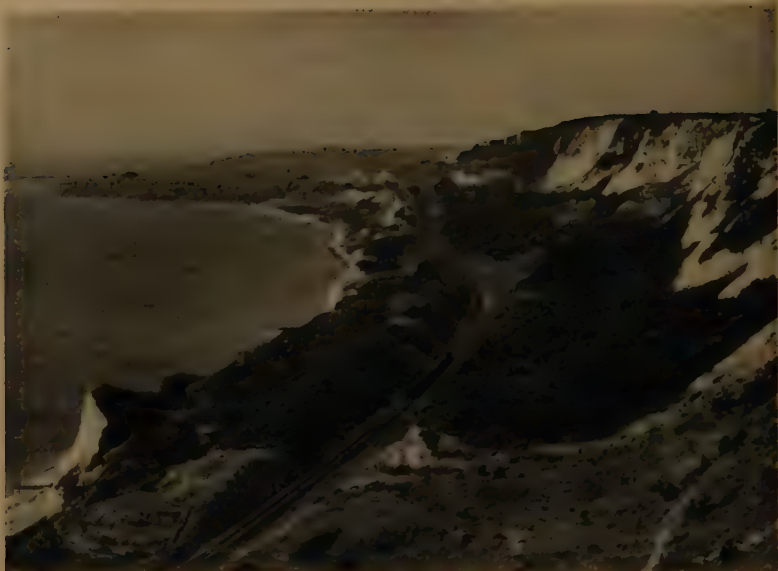
Fig. 2

FOLKESTONE WARREN LANDSLIDE AFTER REBUILDING OF THE RAILWAY

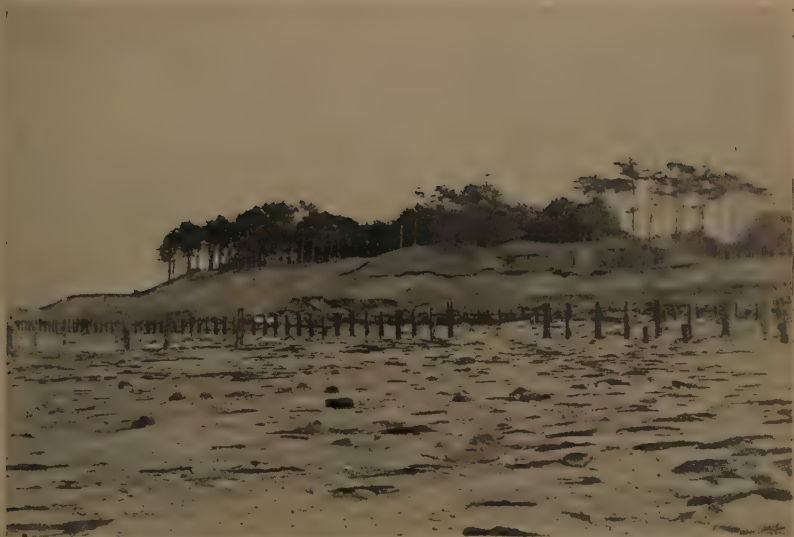
Fig. 3

CENTRE VIEW BEFORE COMMENCEMENT OF WORK, SHOWING EROSION AND
STORM DAMAGE

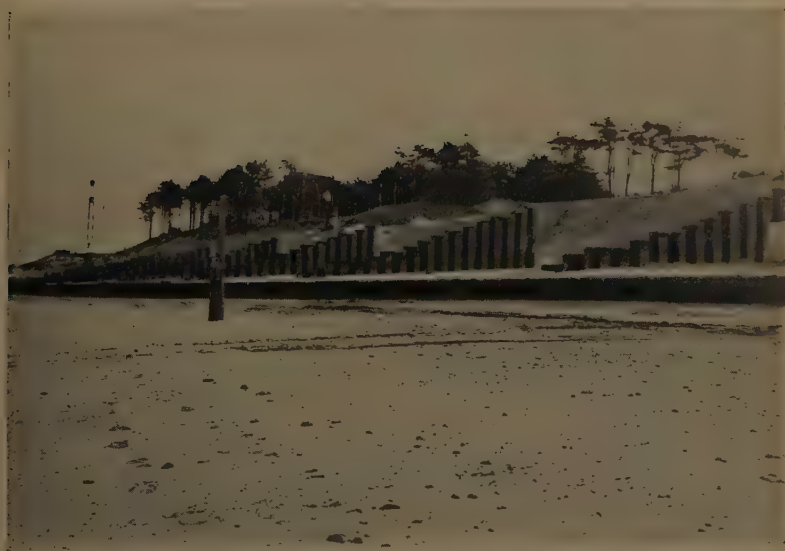
Fig. 4

CENTRE VIEW, SHOWING STEEL SHEET-PILING IN FRONT WITH STEPPED
CROSS-PILING AND COMMENCEMENT OF FILLING

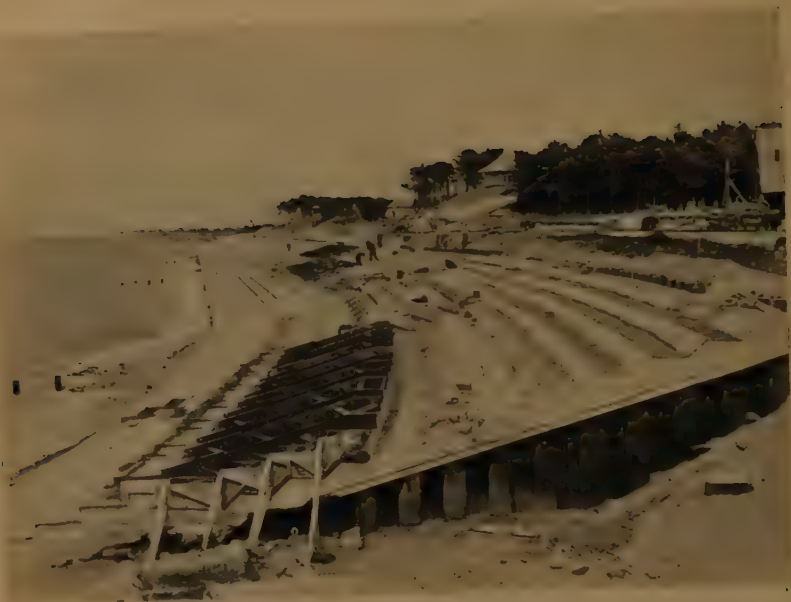
Fig. 5

VIEW FROM SOUTH END, SHOWING CONCRETE STEPPED APRON UNDER CONSTRUCTION

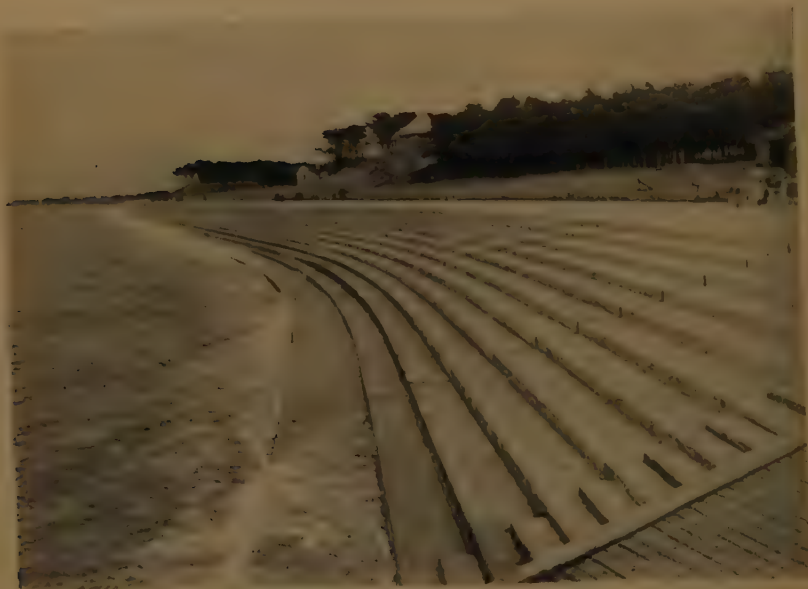
Fig. 6

VIEW FROM SOUTH END, SHOWING COMPLETED WORK

right angles to the treads. This small seaward inclination of the risers has been very successful in controlling the effects of wave splash. The level of the bottom step is 10·00 A.O.D. and the top step 26·50 A.O.D.; contraction joints were formed at 60-foot centres and expansion joints at 300-foot centres; two ramps to permit access to the beach were also formed.

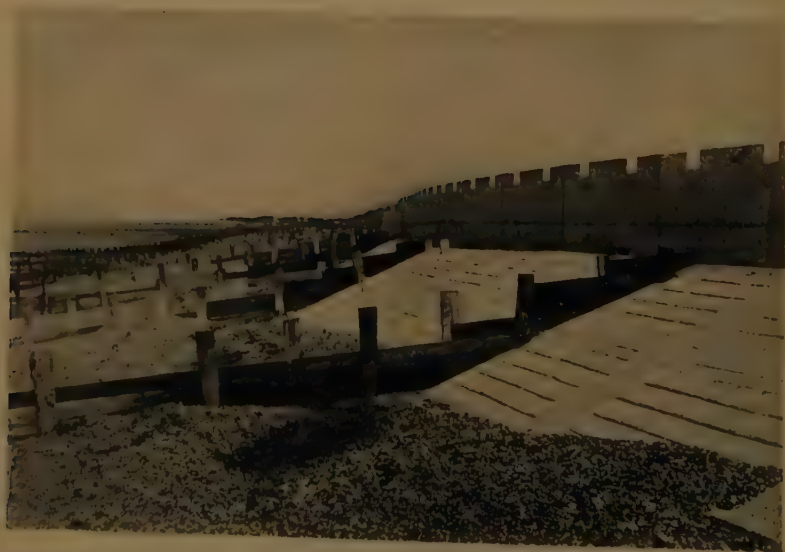
Fig. 3 (b)

NORTHERN SEA WALL—RECVLVER TO BIRCHINGTON—VIEW OF COMPLETED WALL
